Chinook Safety Performance Review

In the five-year period FY15-FY19 (over 365,000 flight hours), the H-47 series aircraft had 41 Class A-C mishaps recorded. There were 5 Class A, 2 Class B, and 34 Class C with a cost of over \$52 million in damage. Thankfully there were no fatalities. The Class A H-47 flight mishap rate per 100,000 hours was 1.37. The Class A-C H-47 flight mishap rate was 8.21. Breakdown by category (i.e., Flight, Flight-Related, Ground) showed that 30 of the 41 mishaps were Flight and the remaining 11 were categorized as four Flight-Related and seven aircraft Ground mishaps. In comparison, the H-47 Class A and Class A-C rate falls between the H-60 Class A and A-C (1.09 and 7.13 respectively) and the H-64 with Class A of 2.11 and A-C of 9.06. For Class A mishaps human error was the primary causal factor in 4 (80 percent) of the incidents with materiel failure accounting for 1 (20 percent). For Class A-C mishaps with a reported causal factor, human error was the cause factor in 68 percent of the mishaps and materiel failure was 26 percent. Environmental factors (e.g., bird strikes) were reported in 6 percent of the cases. Of the 41 incidents, there were seven with

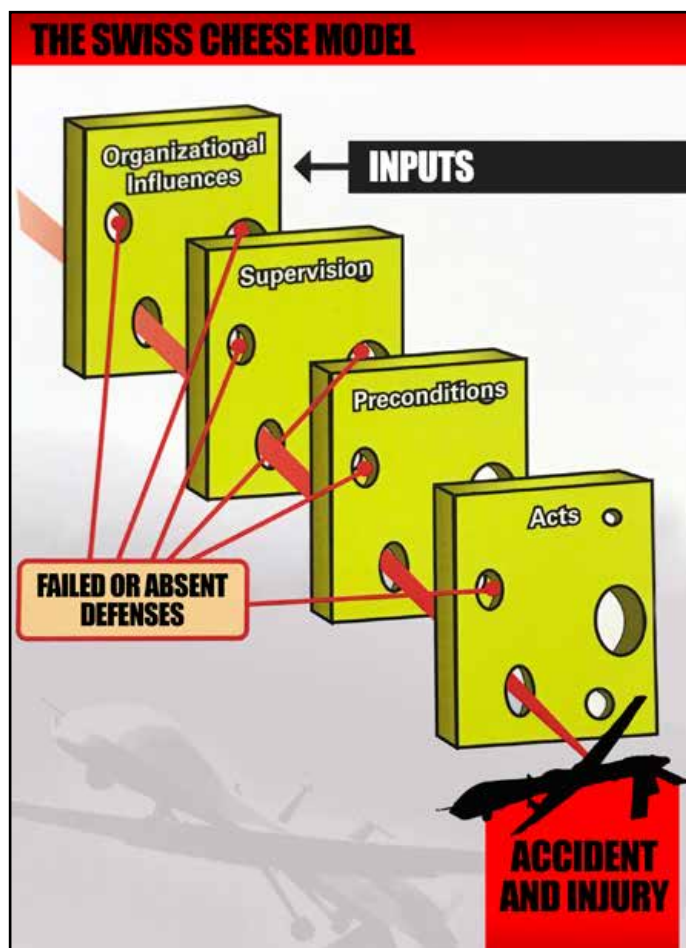
Figure 1. Swiss Cheese Model of Accident Causation

for an accident. James Reason's "Swiss Cheese Model of Accident Causation" (Figure 1. above) shows the successive layers of defenses that are broken resulting in accidents. As you can see from the example above, the holes in the defensive layers begin to line up when we don't adhere to published standards.

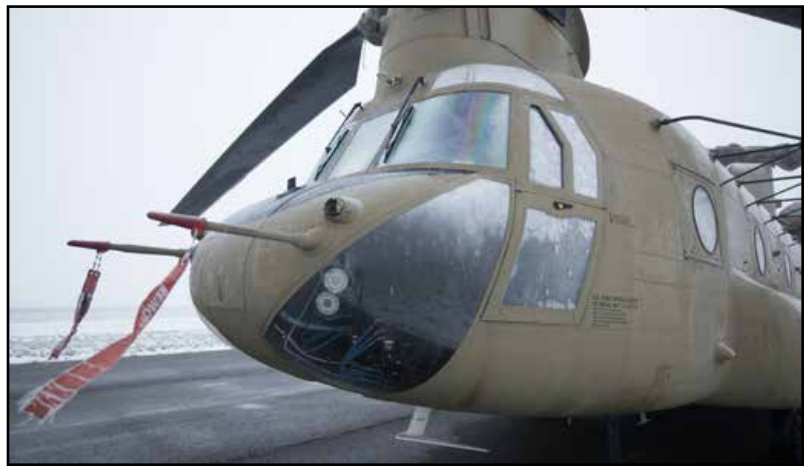
Figure 2. CH-47F with pitot tube covers marked "Remove Before Flight"

In recent years, there have been a few instances where engine inlet FOD screen inlet covers remained installed when they should have been removed before aircraft operation and resulted in engine damage. Something as simple as an inlet cover with a highly visible "REMOVE BEFORE FLIGHT" tag not being removed shows us that individuals are not following the checklist in their rush to complete a task. Foolishly we deviate our operations from the book, maybe because we feel we know everything procedurally or it's what we were taught to do. The fact the Army required installation of a "REMOVE BEFORE FLIGHT" tag on covers and special tools is a built in risk mitigation tool used to prevent individuals from making these major mistakes, yet it happens a few times a year.

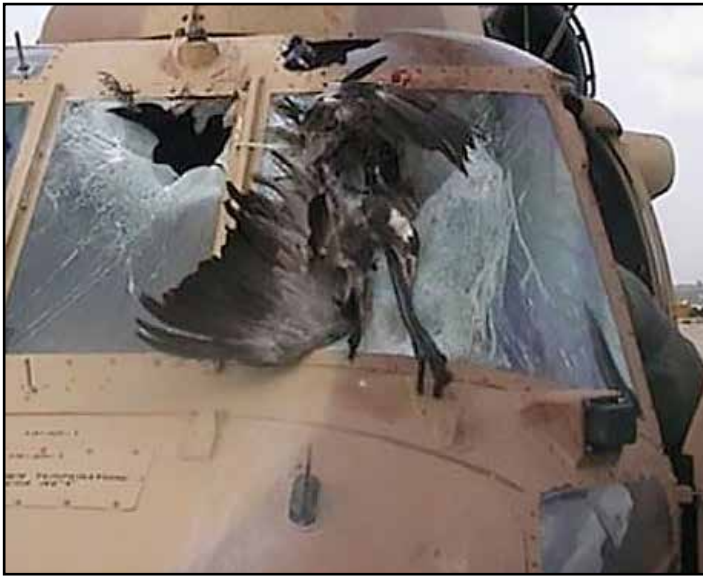
Bird strikes are problems the world over. This photo shows an Israeli Air Force UH-60 Blackhawk after a bird strike. Photo: US Air Combat/Wikimedia Commons
