AH-64 Five-Year Safety Performance Review FY16-20

RQ-7BV2 Shadow Five-Year Safety Performance Review FY16-20

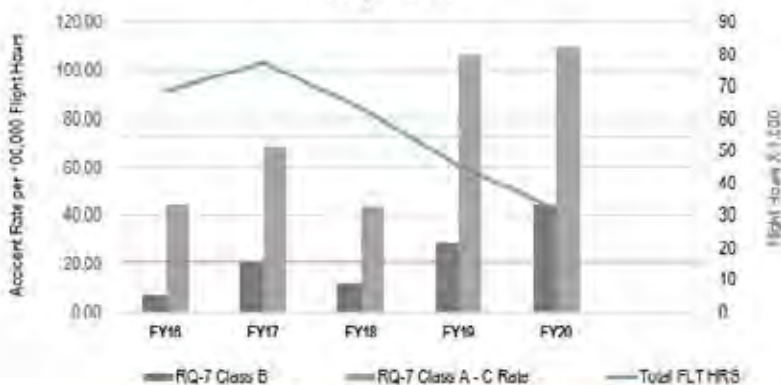
Unmanned RQ-7 Class A - C Mishap Rate

RQ-7	2016	2017	2018	2019	2020
Class B Mishaps	5	16	7	14	14
Class B Mishap Rate	7.26	20.72	11.24	29.15	42.88
Class C Mishaps	26	37	20	38	21
Class B - C Mishap Rate	45.01	68.64	43.34	106.19	107.19
Total # of Flight Hours	68,871	77,286	63,226	48,025	32,651

as of 3 Nov 2020

In the last five-year period from FY16 through FY20, the RQ-7 Shadow program has flown 290,209 flight hours, with 198 total RQ-7 Class A-C mishaps reported. There was one Class A, (one RQ-7BV2 landed on another), 54 Class B incidents and 142 Class C's, with no injuries or fatalities reported. The Class A flight mishap rate was negligible at 0.69, being that one Shadow landed on another, the cost of the two UAS exceeded the Class A threshold. The Class B rate was 18.6 and the Class C rate was 49.0 for the last five years.
