Army Aviation Cold Weather Operations

Flightfax

ARMY AVIATION
RISK-MANAGEMENT
INFORMATION

JUNE 1997 ♦ VOL 25 ♦ NO 9

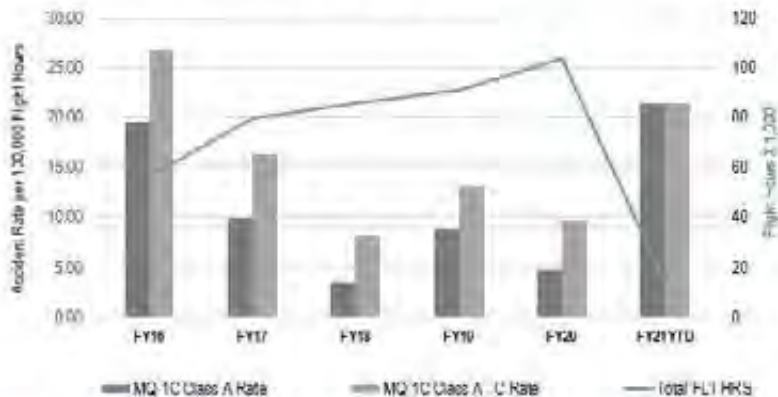
Unmanned MQ-1C Gray Eagle Class A - C Mishap Rate

Trend Comments

- Downward trend in mishaps FY19 – FY20
- FY20: 5 x MQ-1C Class A mishaps, rate 4.82
- FY20: 10 x Class A – C mishaps, rate 9.63

In the last five-year period from FY16 through FY20, the MQ-1C Gray Eagle program had a total of 60 MQ-1C Class A-C mishaps reported. There were 36 Class A, 10 Class B (one ground) and 14 Class C (one ground) mishaps, with no injuries or fatalities reported. The Class A flight mishap rate was 8.40 and the A-C rate was 13.45 for FY16-20.
