## Keep Driving Mishaps Down Every Quarter, not just the 4th Quarter

## Winter is Coming *Flightfax September 1996 message*

# Winter Icing

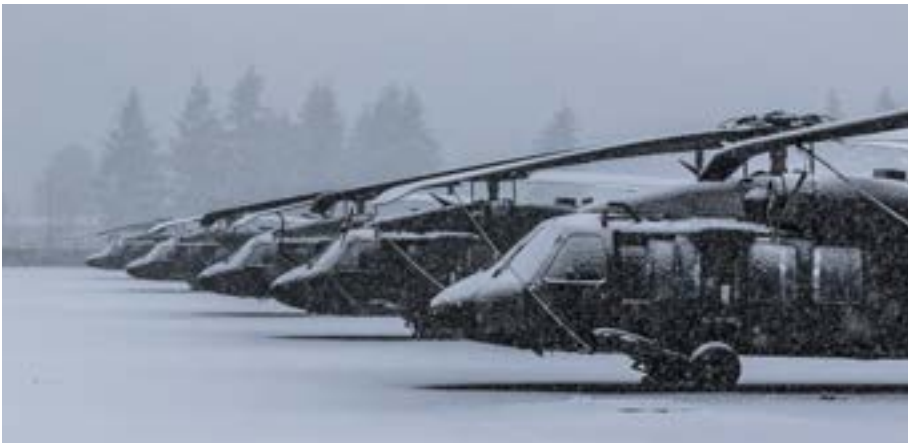
The rate of icing accumulation depends on three variables airspeed, droplet size, and aircraft size/shape. As the airspeed of the aircraft increases, so does the rate of ice formation---to a point. At very high airspeeds (575 knots or greater), heat generated

by friction on the skin of the aircraft actually serves to melt the ice. The rate of ice formation increases as the droplet size increases. When an aircraft flies through clouds or precipitation, the smaller droplets move with the deflected air stream and therefore do not collect on the aircraft. Although larger drops are not so easily deflected and can form ice deposits. Finally, the rate of ice accumulation depends on the size, shape and smoothness of the aircraft surfaces. A large, non-streamlined aircraft will see ice accumulations more quickly than a thin, smooth, streamlined aircraft. It should be noted that once ice accumulation begins, the rate of accumulation increases because the ice increases the aircraft's surface area.

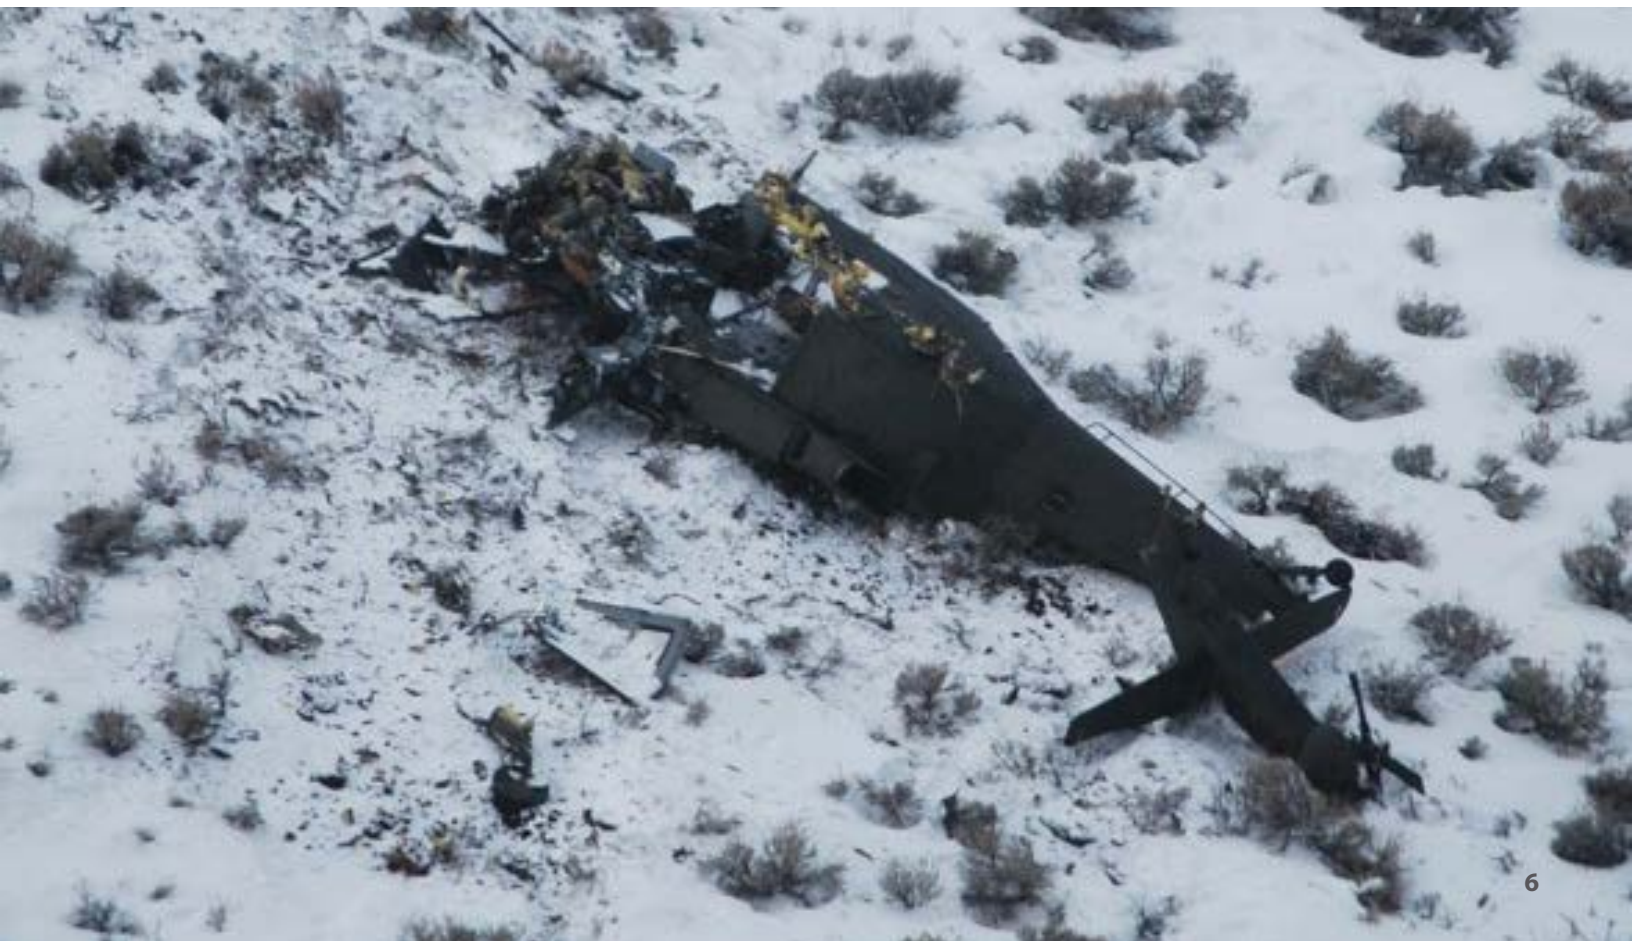
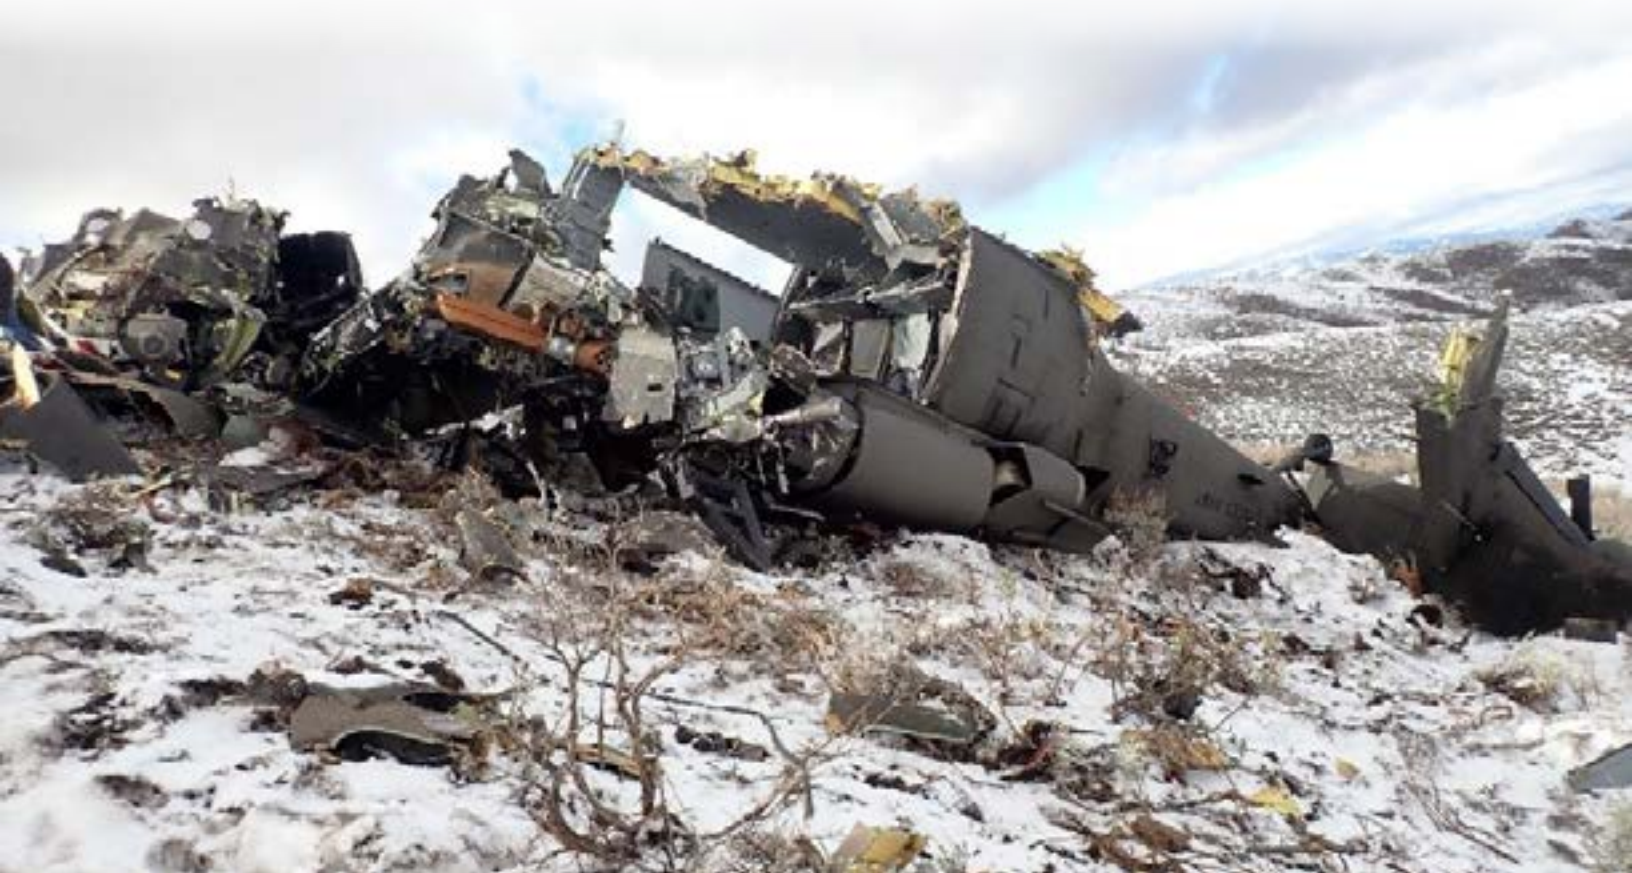
As the mishap crew flew their pre-planned route to the east, turning north into the NOE training area, they began to encounter pockets of rain and snow occasionally reducing their visibility. At the same time, a snowstorm was approaching their location

from the west. Once the mishap crew completed the training and evaluation tasks, they turned west towards the airport.

At 1943L, the mishap aircraft reported to flight operations that they were en route back toward the airfield and began working their way along the snow-covered terrain as the weather continued to deteriorate. The aircraft encountered increased precipitation and reduced visibility, and initiated an IIMC recovery at 1949L. The aircraft impacted terrain below a ridgeline resulting in destruction of the aircraft and fatal injuries to the three crewmembers.
